**PHASE I ENVIRONMENTAL SITE ASSESSMENT  
3B TECH COMPUTERS & ST. CLAIR APPAREL, INC.  
3431 WILLIAM RICHARDSON DRIVE  
SOUTH BEND, INDIANA**

**Project No. 186174-3814**

**July 2015**

**ENVIROCORP, INC.  
South Bend, Indiana  
*A PARSONS BRINCKERHOFF COMPANY***

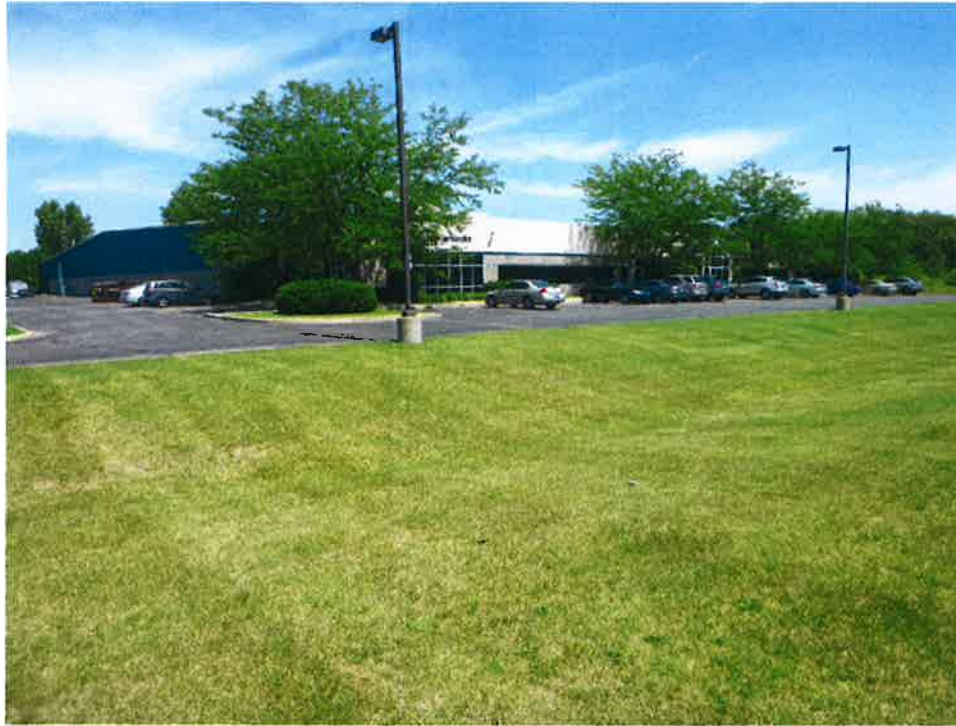
11: Exterior southwest corner of the building on the subject property, facing northeast.

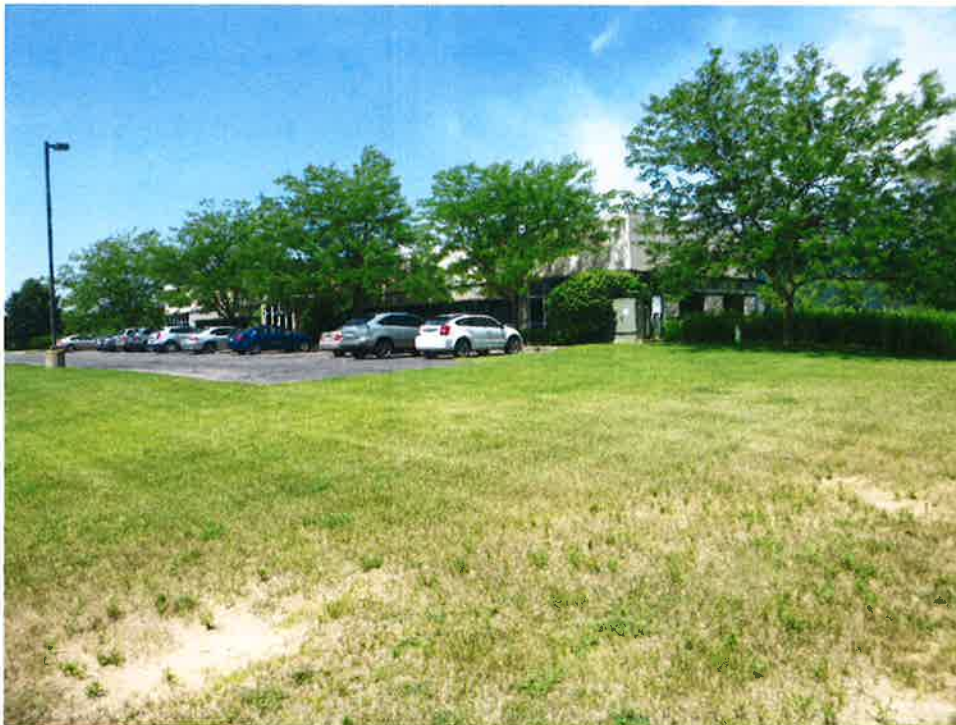
12: Exterior southeast corner of the building on the subject property, facing northwest.

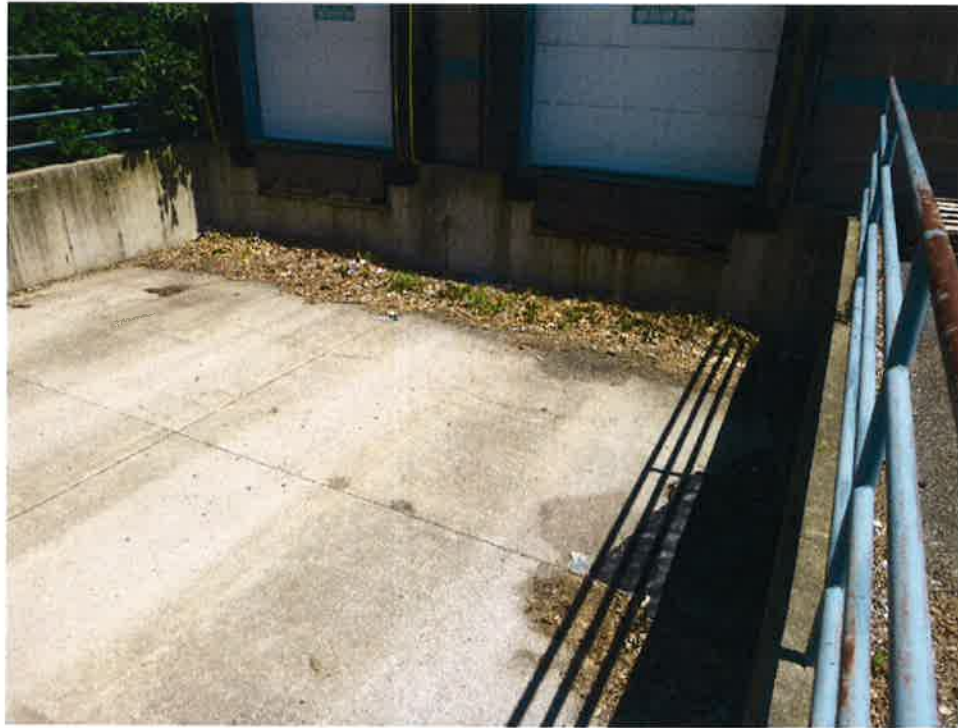
13: View of the french drain observed in the sunken loading dock on the western side of the building on the subject property, facing east.

Floor drains were observed within the restrooms and furnace rooms in the building during the site walkover. The floor drains reportedly discharge to the municipal sewer system. No outside drains were observed in the parking lot on the subject property during the site walkover. No obvious stains or odors were noted in association with any of the interior and/or exterior drains observed on the subject property which might suggest a significant release of a chemical or petroleum material.

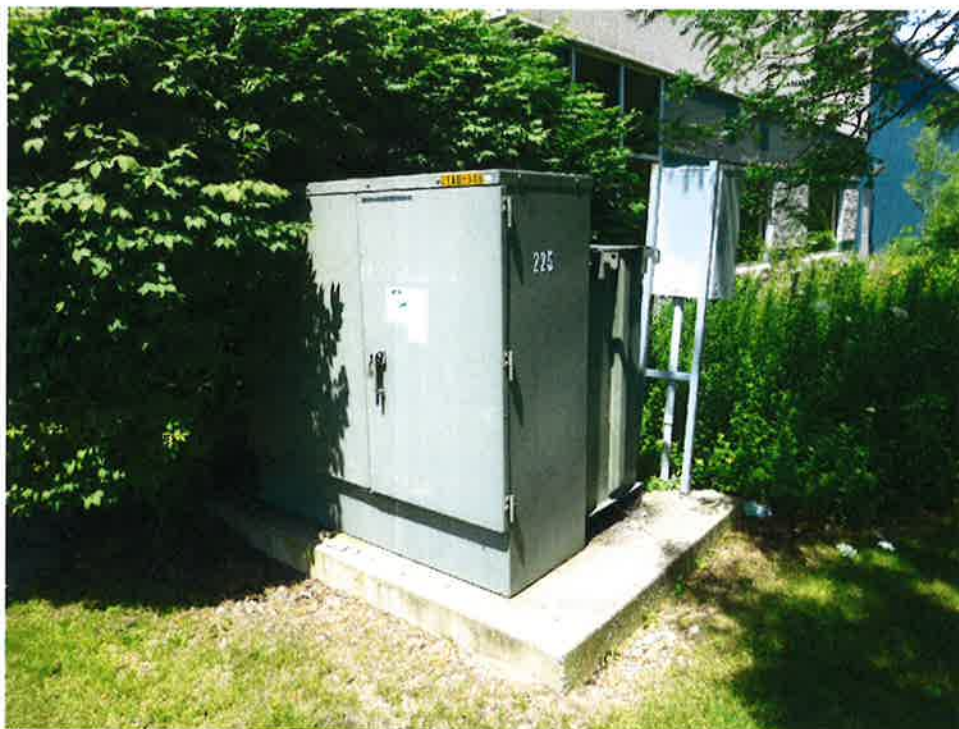
14: View of the pad mounted electrical transformer observed east of the southeast corner of the building on the subject property, facing north.

One exterior and one interior pad-mounted electrical transformers were observed on the subject property at the time of the site walkover. The exterior transformer had a label which indicated that the insulating oil contained less than 2 parts-per-million (ppm) PCBs and is, therefore, considered "PCB-Free." The exterior transformer appeared to be in good condition with no evidence of fires, leaks, or corrosion. The interior dry-type electrical transformer has no oil. No in-ground hydraulic equipment or lines are currently used, or are believed to have been historically used, on the subject property.

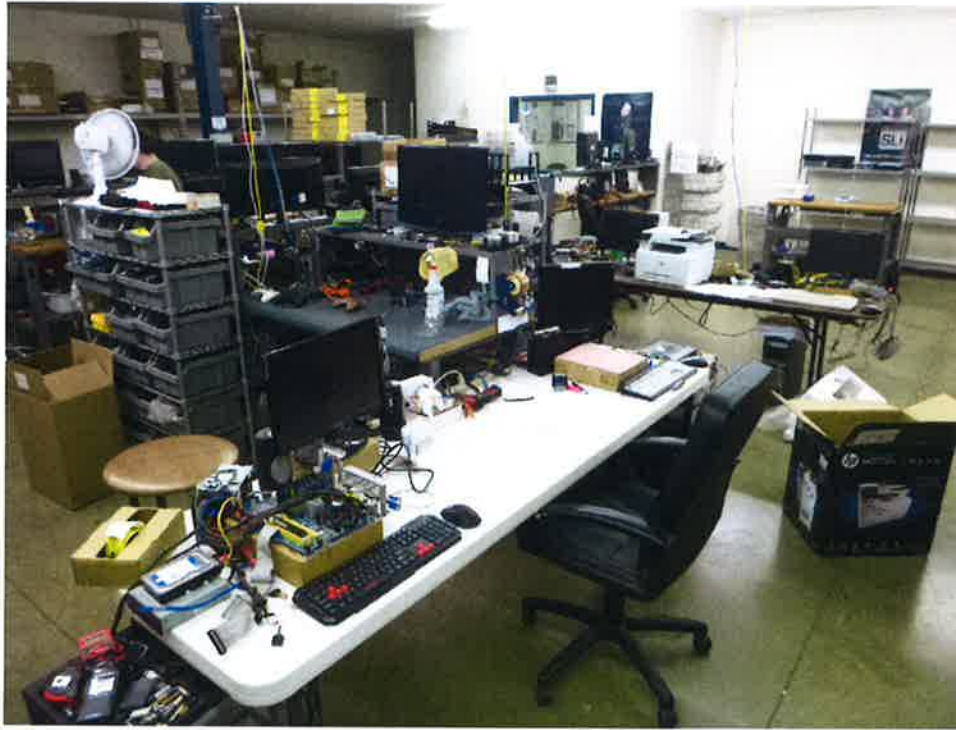
15: Interior view of the workshop portion of the 3B Tech Computers portion of the building on the subject property, facing northeast.

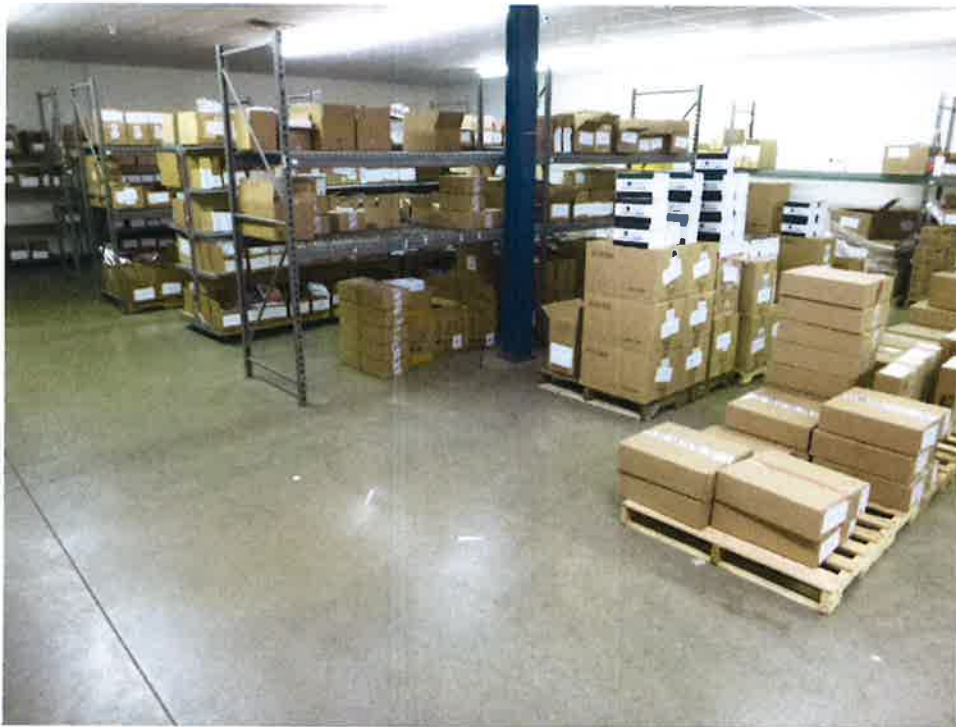
16: Interior view of the warehouse portion of the 3B Tech Computers portion of the building on the subject property, facing southeast.

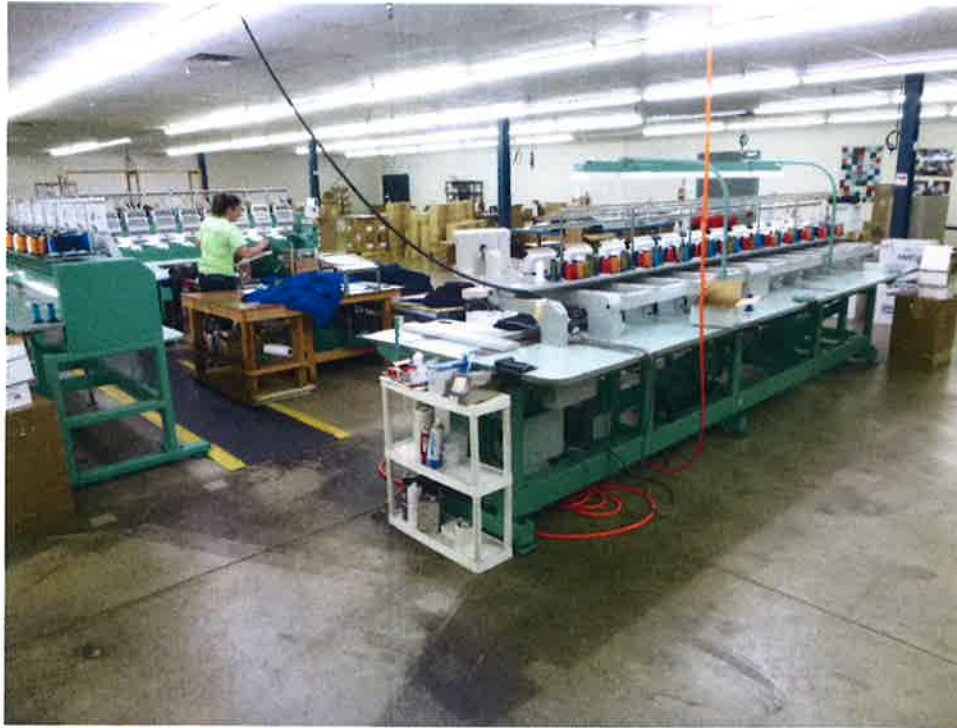
17: Interior view of the shop portion of the St. Clair Apparel portion of the building on the subject property, facing northwest.

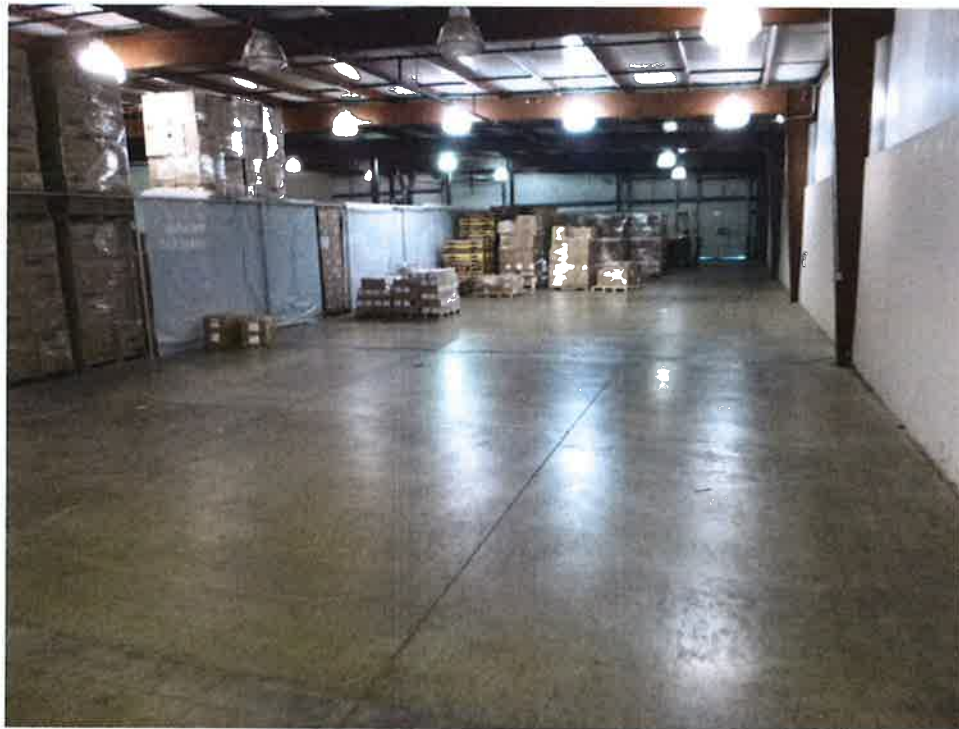
18: Interior view of the warehouse portion of the St. Clair Apparel portion of the building on the subject property, facing west.
